# Firmware update

## MODECOM FREEWAY MX

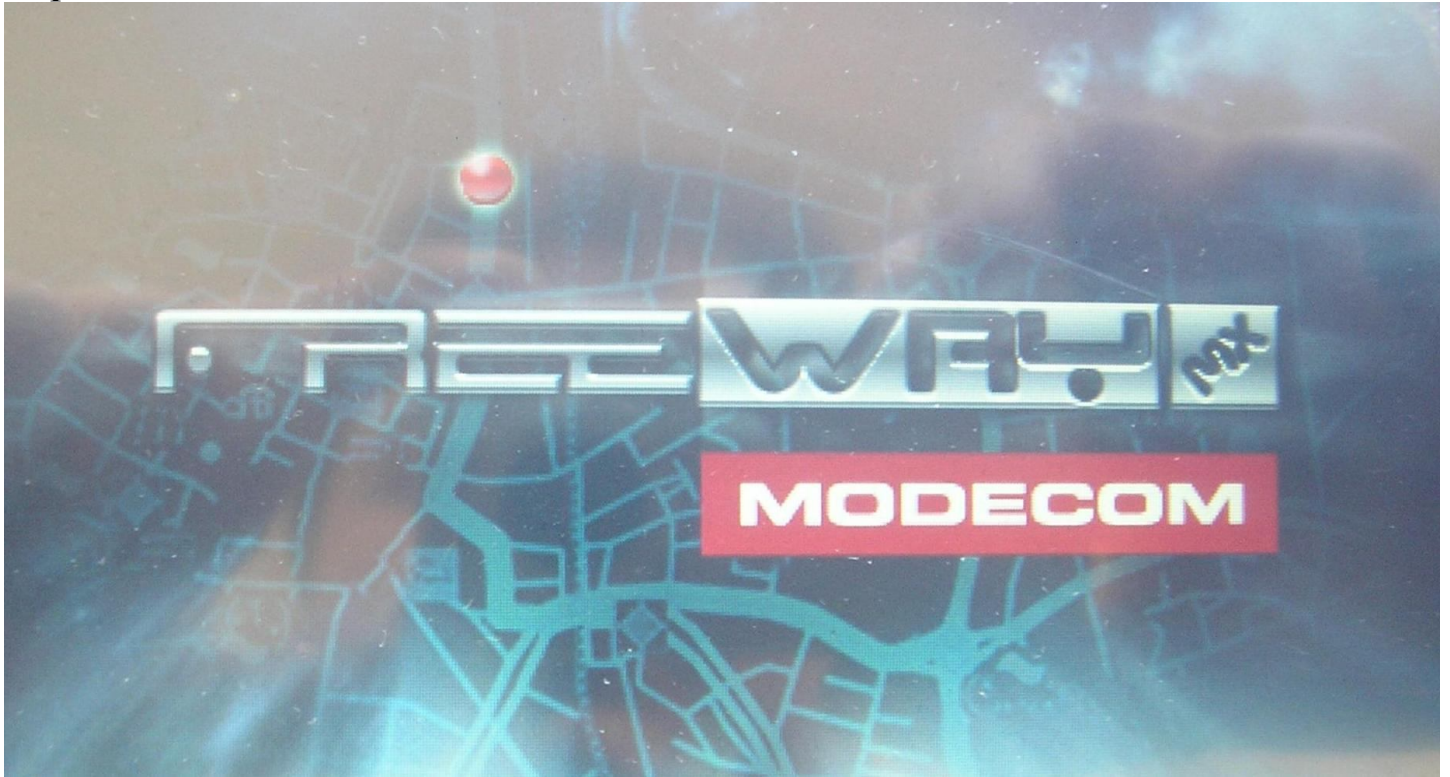
If you run MX FREEWAY device in service mode and after leaving it boot (starting) sequence stops at the logo image, make the firmware update by following steps:

1. Insert the SD card slot device with the previously downloaded firmware files (YFAPP.wzp, os82c.img, Logo82c.bmp).
2. Plug the AC charger.
3. Push power button for a moment.
